FULL SCALE CAR BURNS IN THE SYDNEY HARBOUR TUNNEL

Dr Nick Agnew¹, Bob Allen²
Fire Australia 2008

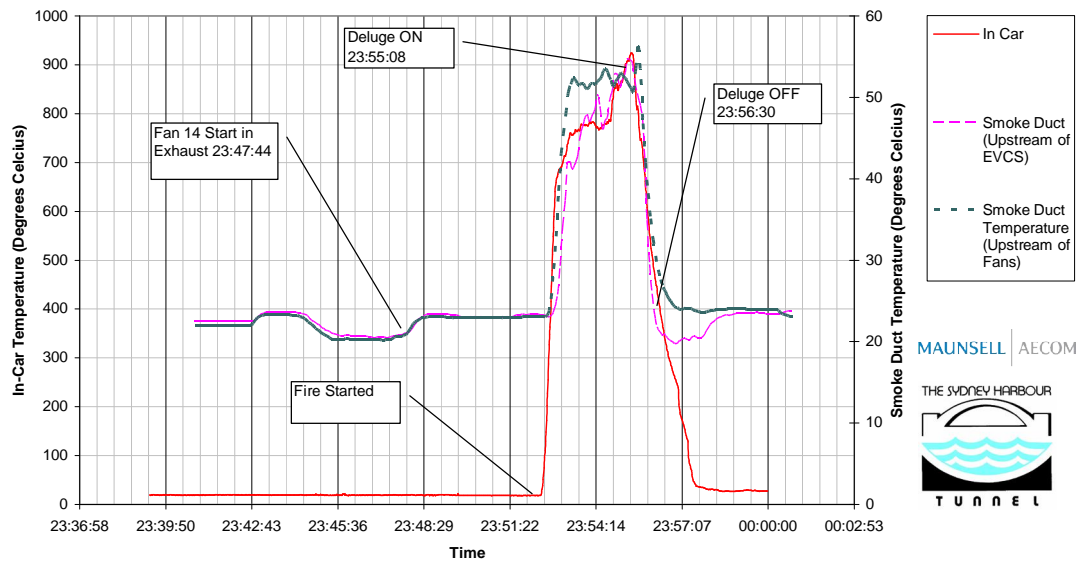
Figure 3 - Test 1 temperature

Figure 3 summarises the temperature data collected for Test 1. The traces shown correspond to the in-car temperature and the two smoke duct temperatures. At its peak, the gas temperature in the car reached approximately 900°C (within three minutes from ignition). A temperature in the car of 800°C was reached in less than 1.5 minutes from ignition. The peak temperature in the smoke duct reached approximately 55°C immediately downstream of the open damper. The temperature increases in the car and within the smoke duct decayed very quickly upon activation of the deluge above the fire.

From the smoke duct temperatures and measured radiation, it is estimated that Test 1 resulted in a peak heat release rate of approximately 3MW. Despite the flame impingement on the ceiling damper above the car, no observable damage was sustained to the damper nor were any light fittings to the side of the fire site adversely affected.

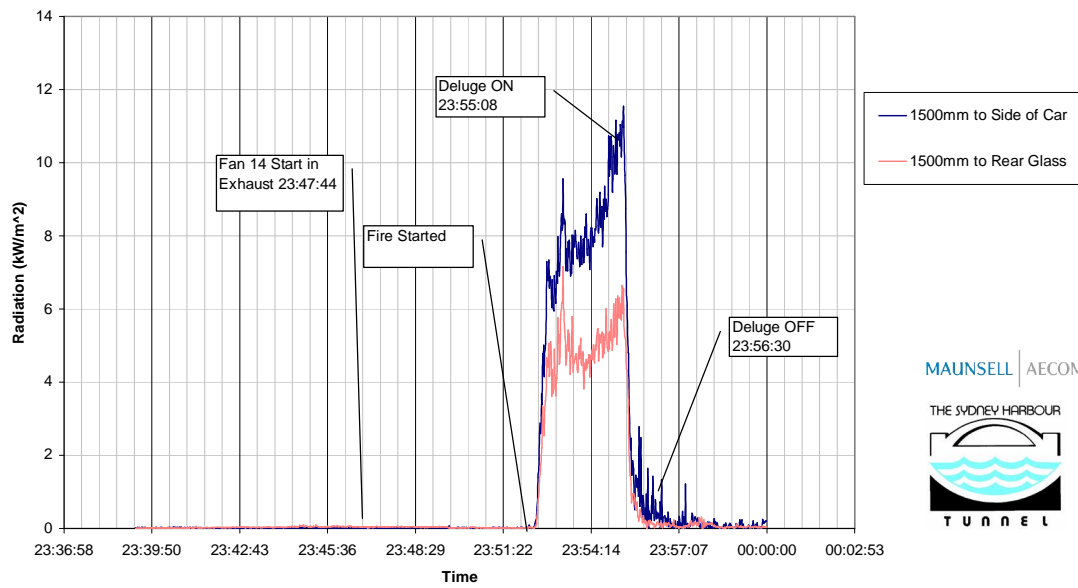
Figure 4 - Test 1 radiation

Figure 4 summarises the radiation data collected for Test 1. Incident radiation 1500mm to the side of the vehicle reached approximately 11kW/m². To the front of the car, the value achieved was approximately 6kW/m².

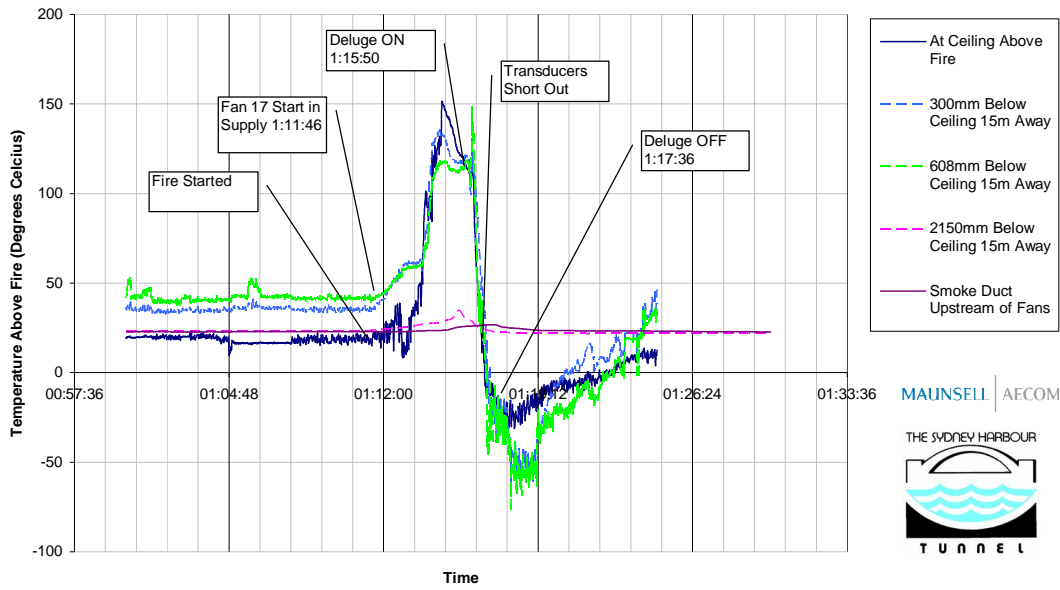
Figure 5 - Test 2 temperature

Figure 5 summarises the temperature data collected for Test 2. Despite the ceiling above the car being exposed to intermittent flame impingement, the bulk smoke layer temperature reported in the general vicinity above the car was approximately 150°C. It is anticipated that where flame was present locally at the ceiling, intermittent temperatures of the order of 800°C to 1000°C may have been experienced directly above the car. Despite the sporadic flame impingement on the ceiling above the fire car, no observable damage was sustained to the tunnel ceiling or side wall structure.

Fifteen metres up and to the north of the fire, temperatures were measured at several distances below the tunnel ceiling (300mm, 608mm and 2150mm). The peak temperatures measured at these locations were 140°C, 120°C and 35°C respectively. Typically for tunnel design, a tenability criterion of 60°C is used for convected heat and so the area immediately downstream of the fire was tenable for temperature up to a height of approximately 4m. No thermal effects specifically caused by steam liberated from the deluge flow were noted. The ambient temperature in the tunnel at the time was approximately 23°C.

At some point following activation of the deluge a number of thermocouples and radiometers were shorted out causing negative values to be logged. The data prior to and, most likely, immediately following deluge activation were unaffected however.

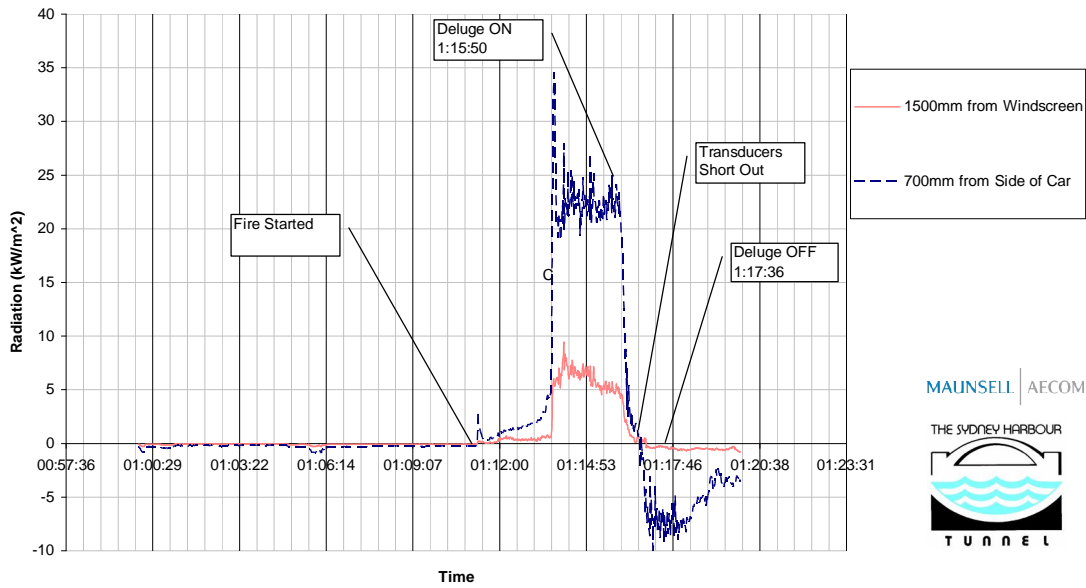
Figure 6 - Test 2 radiation

Figure 6 summarises the radiation data collected for Test 2. Radiation to the side of the vehicle peaked at 33kW/m² and averaged 23kW/m² during the fire. This level of incident radiation would be sufficient to easily ignite most combustible materials in close proximity to the car. In front of the car, the average incident radiation was 6kW/m². Radiation decayed rapidly upon application of the deluge.

It was not possible to estimate heat release for this vehicle fire with the information logged. However on the basis of the high radiation levels in the vicinity of the car it can be concluded that the peak heat release rate was significantly higher than for the Test 1 fire (possibly greater than 5MW). This is consistent with what was visually observed.

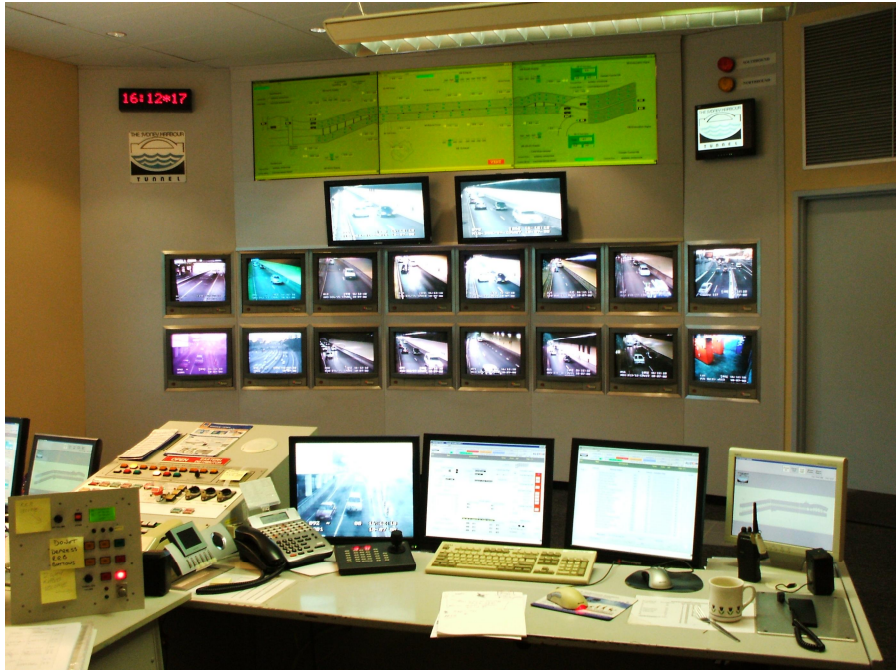
Photograph 1 SHT control room.

Tunnel operators generally spend their time in a control room within a comfortable sterile atmosphere, viewing their domain via a CCTV system without audio. Photograph 1 shows the SHT control room with the SCADA system in the foreground.

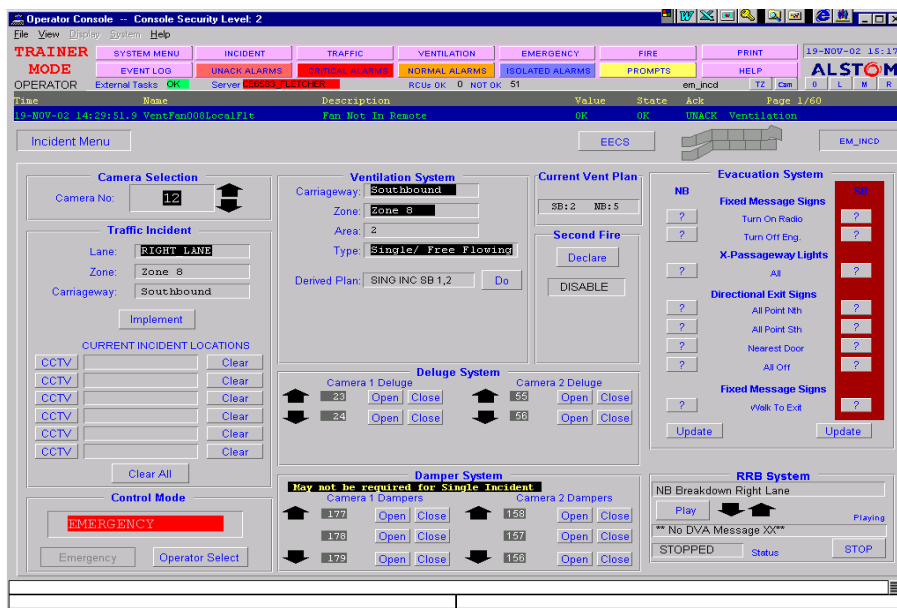
Photograph 2 - SCADA incident management page.

The SHT SCADA system includes numerous screens to assist the operator respond to an incident. Photograph 2 shows the main incident screen which displays the fire location and adjacent CCTV camera zones, the pre-programmed ventilation mode for the fire location, and the appropriate deluge zones to be manually activated. Photograph 3 shows the ventilation screen, giving the operator detailed status indication as well as providing a means for manual control of ventilation elements such as fans and dampers.

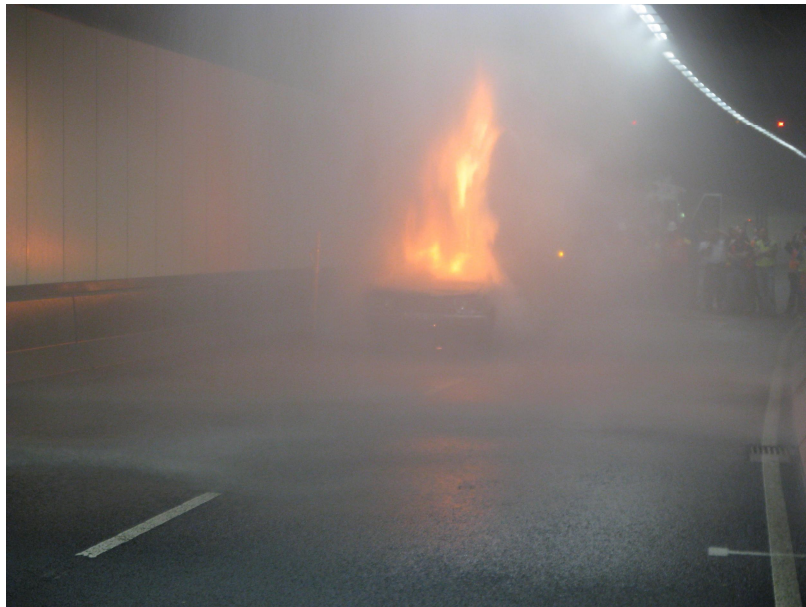
Photograph 4 - Test 1 - visibility after deluge activation (better than 30m). There is no smoke as the damper is directly above the fire.

Smoke was efficiently exhausted from the tunnel through the damper directly above the fire and there was limited smoke spread upstream and downstream. Because no smoke layer was allowed to develop, activation of the deluge did not cause a complete loss of visibility through the 30m long deluge zone at the fire site (Photograph 4) (i.e. visibility of at least 30m).

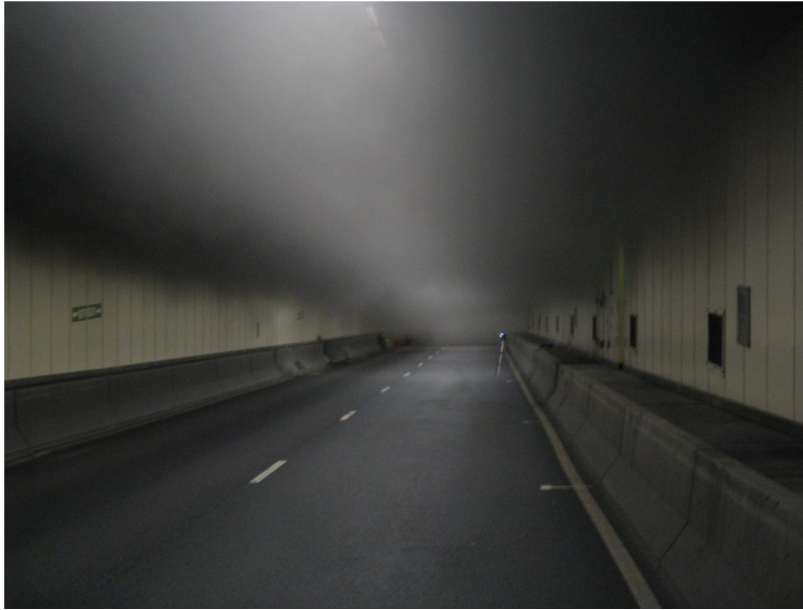
Photograph 5 - Test 2 - stratification of smoke 200m away downstream (to the north) from fire immediately after deluge was shut off.

Once deluge was activated, visibility was lost at the fire site. That is, down-mixing of smoke by the deluge was generally limited to the deluge zone. Away from the fire site, the smoke and steam retained sufficient thermal buoyancy to eventually re-stratify downstream, with a low level clear air layer flowing in from behind the smoke providing relatively clear conditions below the smoke layer. This continued after the deluge was turned off (Photograph 5).

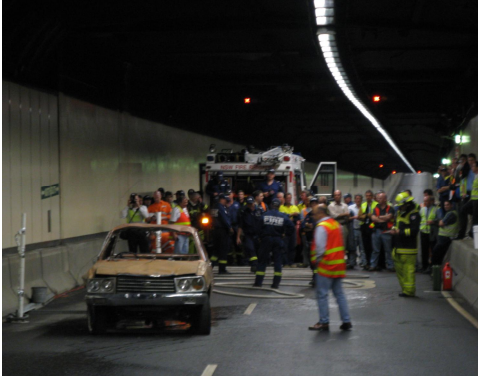
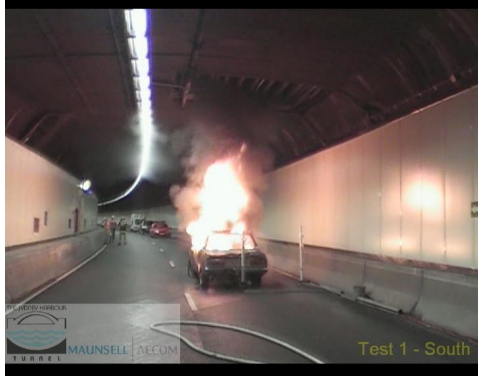
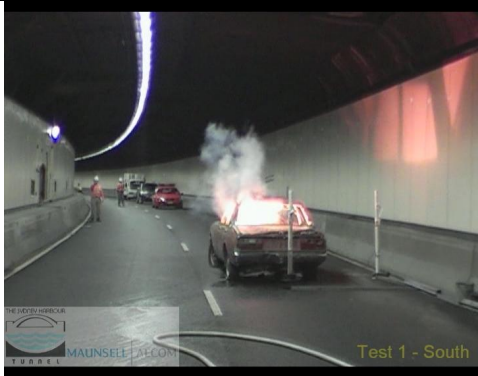
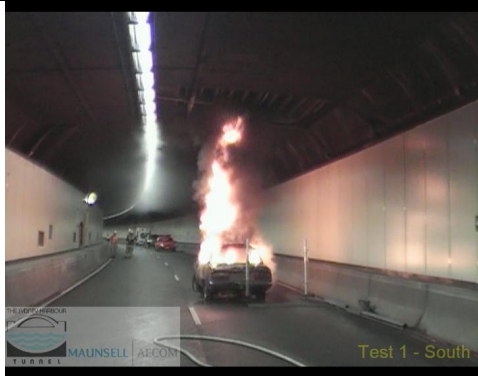
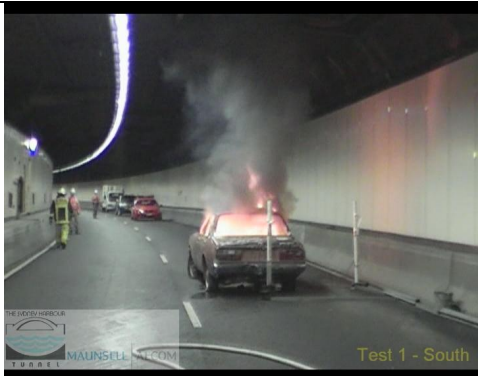
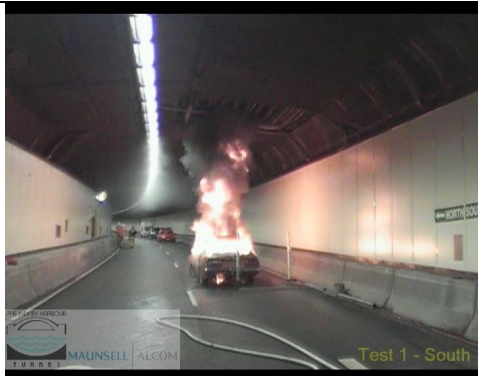
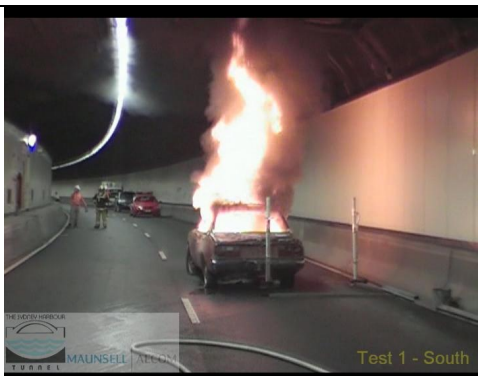
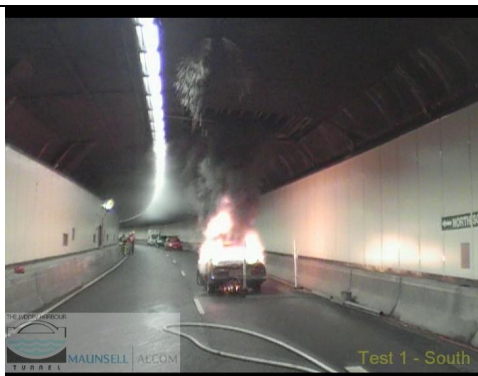
Table 1 - Test 1 view from south (approximate time from ignition shown in minutes : seconds)

00:00	Ignition.
00:30	Peak heat release attained based on observable maximum plume height.
02:00	Fire observed under the car.
02:54	Deluge on.
02:58	Flaring up of the fire caused by deluge. Fire impinging onto ceiling damper. Flame penetrating ceiling damper into the smoke duct.
03:10	Flaring stops.
03:15	Combustion external to the car is suppressed. Combustion still occurring in car.
03:56	Internal fire mainly suppressed.
04:25	Deluge off. Remaining combustion attacked by fire crew.
04:43	Limited smouldering combustion inside car.
05:00	Fire completely out.

Table 1 in Section 12 shows a series of video frames highlighting key events as seen from the south (downgrade) of the test location. Table 2 shows a series of frames as viewed from the north (upgrade) of the test location.

It was noted that a deflagration (flash fire) event was initiated within a few seconds of the deluge being activated (i.e. a flaring-up of the fire). This phenomenon, which has been previously observed for misting systems acting on hydrocarbon pool fires^[3], is thought to be caused by flash vaporisation and the additional turbulence to stimulate both the pyrolysis / evaporation of the fuel and the combustion reaction. This effect was highly localised and

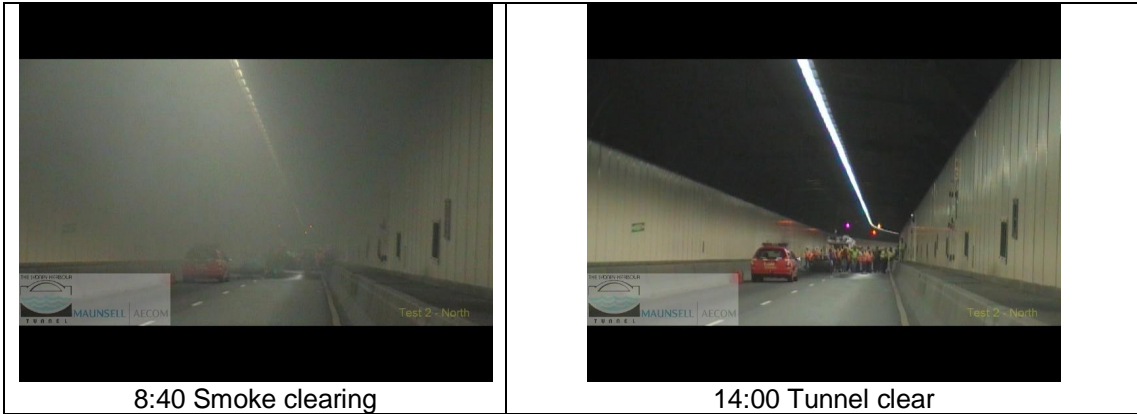
Table 4 - Test 2 view from north (approximate time from ignition shown in minutes : seconds)

05:07	Visibility is lost from northern viewpoint locally through fire site.
05:24	Combustion generally controlled within the vehicle. Significant combustion still present externally beneath the car and to the rear of the car.

05:27	Visibility completely lost roadway to ceiling within 100m to the north of the fire site. Beyond 100m to the north the visibility seemed to be tenable.

06:20	Smoke clears to the south of the fire site as smoke is driven to the north with a change in ventilation mode. External combustion present beneath the car and to the rear of the car.

06:41	Deluge off. Tunnel to the south of the fire site is clear of smoke. To the north, smoke is destratified within 150m of the fire site. Visibility is poor in this area. Beyond approximately 200m north of the fire site, smoke is generally stratified and visibility at the roadway appears to be greater than 50m (Photograph 5).
07:13	Manual extinguishment commenced.
07:40	Fire mainly suppressed except for small localised combustion areas beneath car. Smoke starts to disperse to the north.
08:40	Partial visibility (much better than 50m) restored to the north of the fire site.
14:00	Tunnel almost completely cleared of smoke.

Table 3 in Section 13 shows a series of video frames highlighting key events as viewed from the south of the test location. Table 4 shows a series of video frames as viewed from the north of the test location.
